DYNAMIC SCIENCE, INC.
In-Depth Accident Investigation

Contract Number DTNH22-94-D-27058
Case Number DSI-94-AB-006

TECHNICAL SUMMARY

[REDACTED]
This three vehicle collision occurred on a two-lane, undivided, urban roadway in [REDACTED] Maryland during the afternoon hours of a winter weekend [REDACTED] 94).

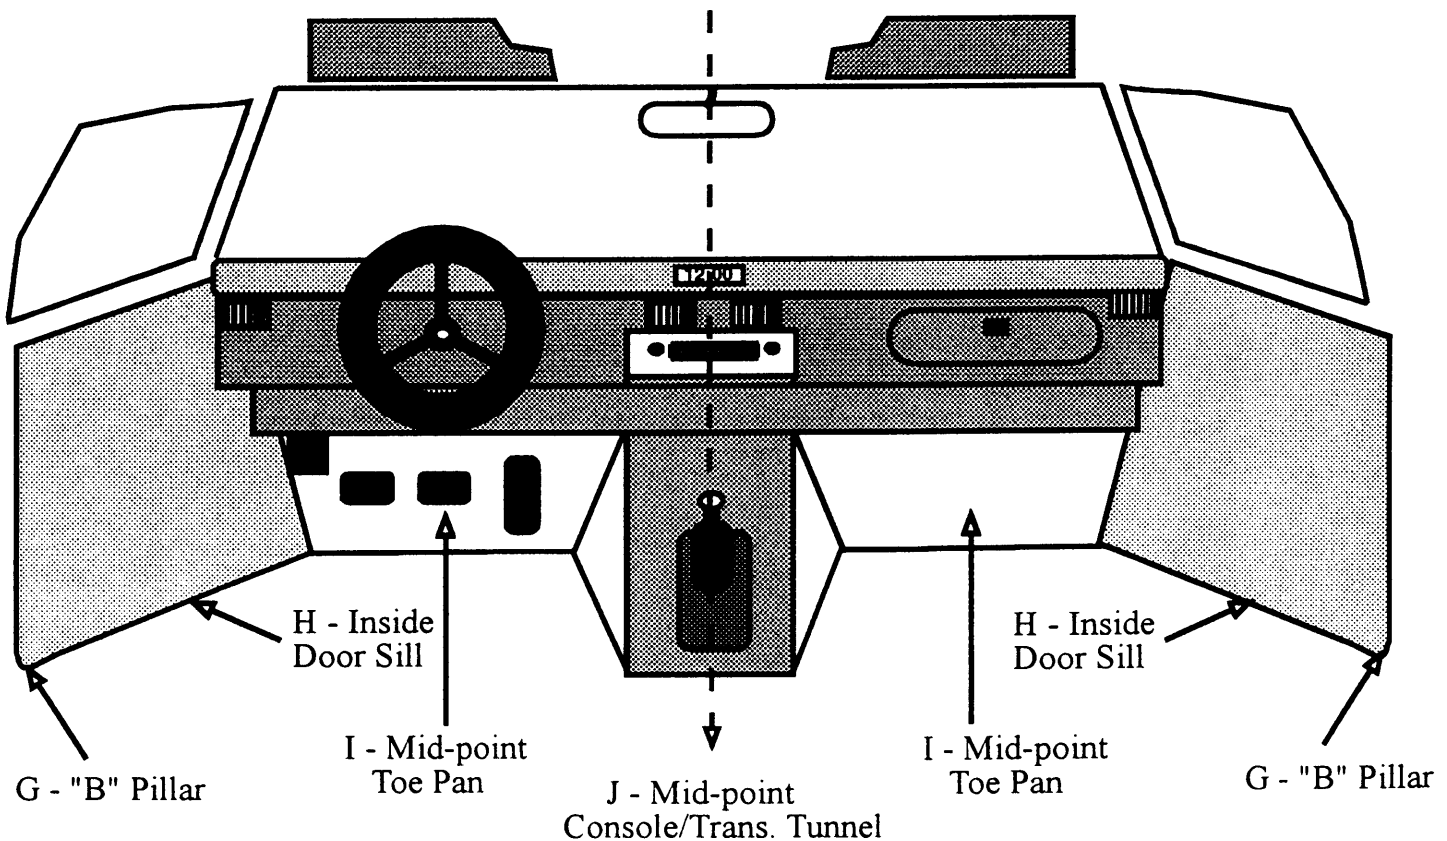
Right Side

A-B	<u>48.6</u>	cm	<u>19.1</u>	in
B-C	<u>7.0</u>	cm	<u>2.8</u>	in
B-D	<u>48.0</u>	cm	<u>18.9</u>	in
A-B-C	<u>96.6</u>	cm	<u>38.0</u>	in
C-E	<u>51.0</u>	cm	<u>20.1</u>	in
B-E	<u>28.0</u>	cm	<u>11.0</u>	in

Left Side

G-I	<u>104.6</u>	cm	<u>41.2</u>	in
H-J	<u>80.0</u>	cm	<u>31.5</u>	in

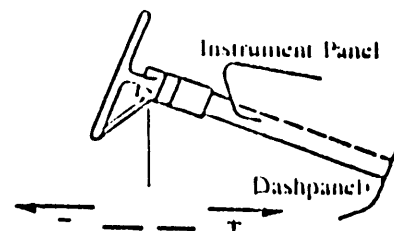
Longitudinal Movement

ALL MEASUREMENTS APPROXIMATE DUE TO EXTRICATION DAMAGE

COMPARISON VALUE	—	DAMAGED VALUE	=	MOVEMENT
VERTICAL					+ MOVEMENT - UNMEASURABLE - ESTIMATED = + 14 cm (4.6")
LATERAL					+ MOVEMENT - UNMEASURABLE - ESTIMATED = + 7.6 cm (3.0")
LONGITUDINAL					φ - 22.4 cm (-8.7 in) = -22.4 cm (-8.7 in)

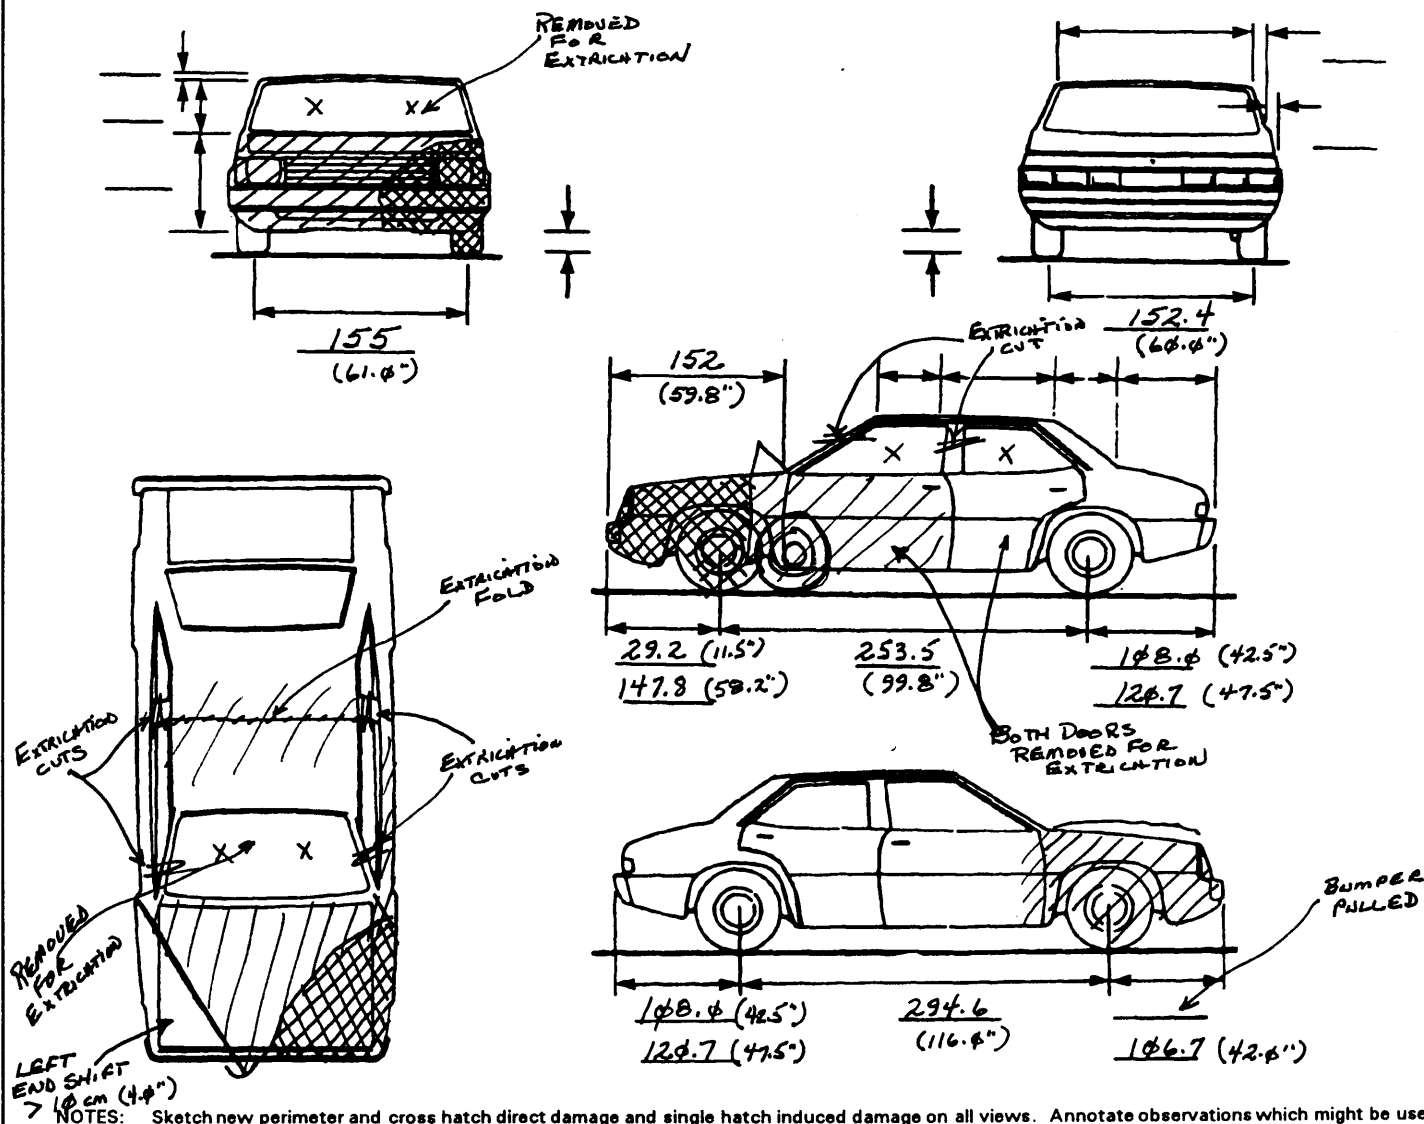
VEHICLE DAMAGE SKETCH

The left front plane of Vehicle 1 impacted the left front plane of Vehicle 2 in a head-on configuration. The Delta V for Vehicle 1 was computed, using CRASH III PC, as 38.5 KPH (23.9 MPH) using a CDC of 92FYEW4 and a PDOF of 355 degrees. The combined direct and induced damage width was 160 cm (63 in), and the maximum crush depth was 104.5 cm (41.2 in) at C₁. The Delta V for Vehicle 2 was computed, using CRASH III PC, as 37.2 KPH (23.1 MPH) using a CDC of 92FYEW4 and a PDOF of 355 degrees. The combined direct and induced damage width was 156 cm (61.4 in), and the maximum crush depth was 77.1 cm (30.4 in) at C₁. The forces in this impact exceeded the manufacturer's threshold in the supplemental restraint system of Vehicle 1 and the driver's side airbag deployed.

MEASUREMENTS IN CENTIMETERS

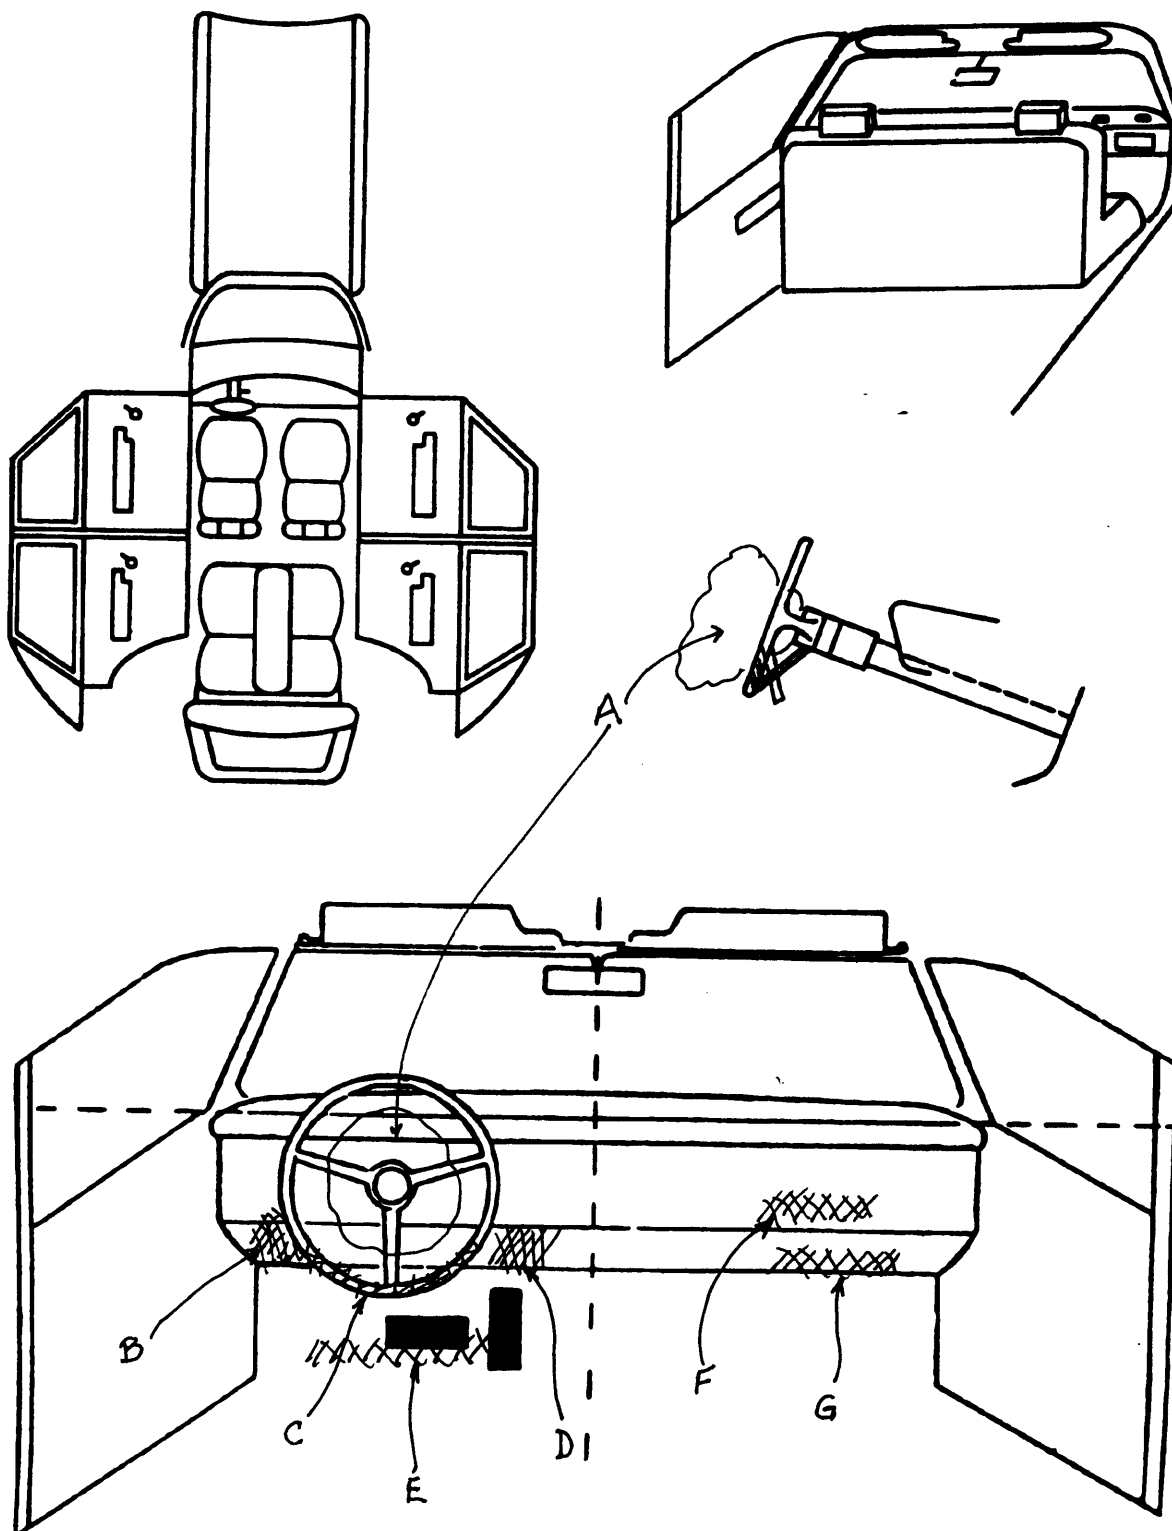
VEHICLE INTERIOR SKETCHES

At impact, the unrestrained driver (the case occupant) was projected forward, upward and to the left. This movement caused her to override the deploying airbag and her head impacted the left "A" pillar and left front door glazing resulting in a closed head injury with loss of consciousness of undetermined duration. At the same time, her right hand was projected from the steering wheel rim into the upper left instrument panel resulting in a colles fracture of the right wrist.

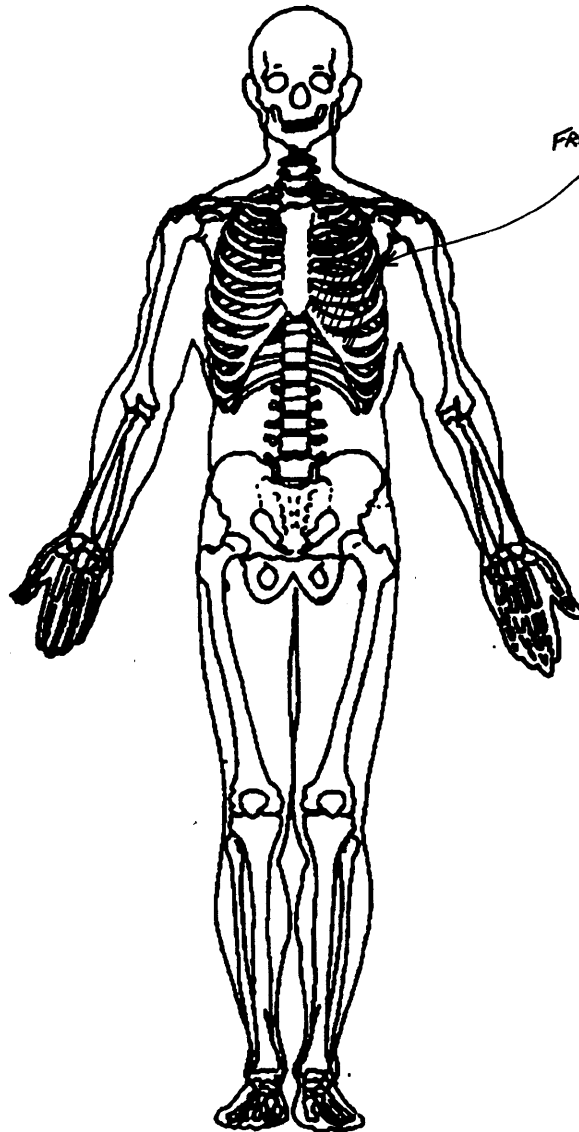
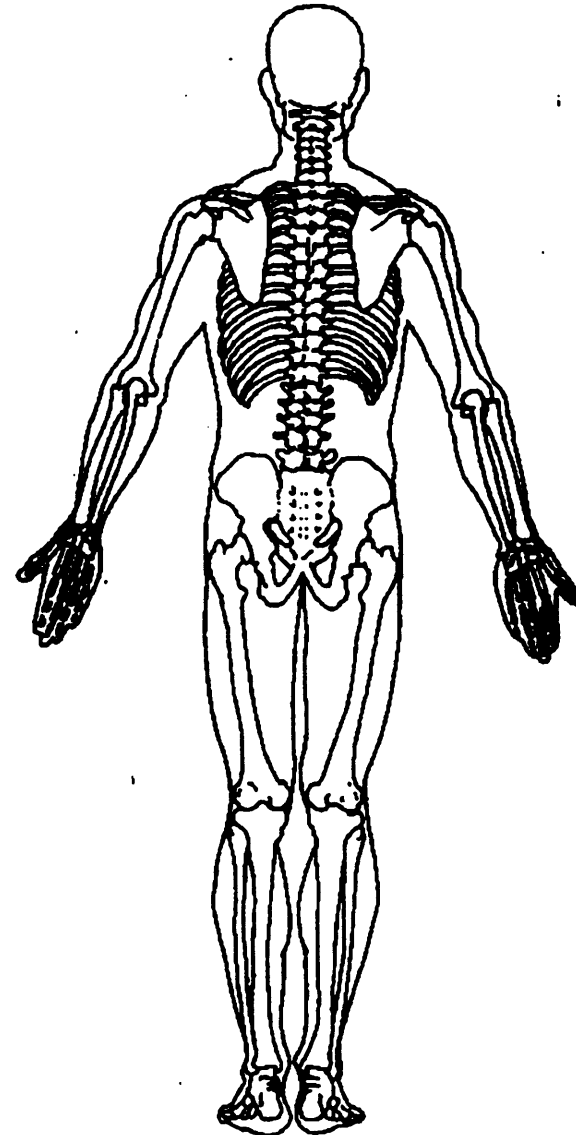
FRACTURES (MULTIPLE)
L. RIBS
R. INST RIB CAGE

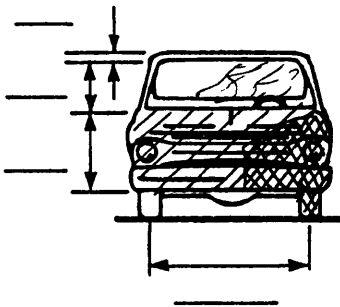
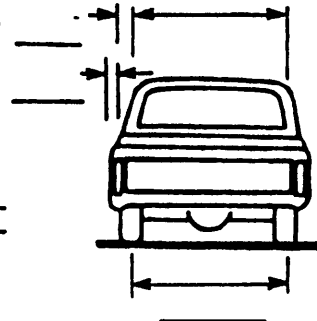
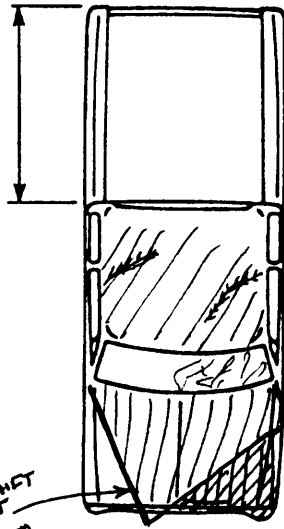
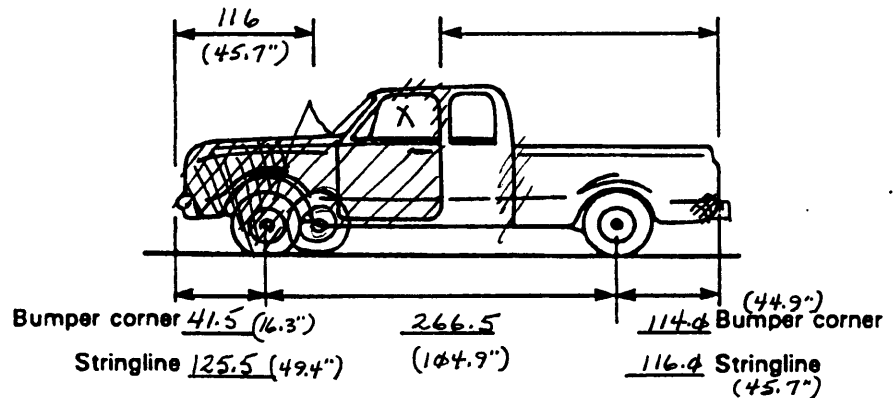
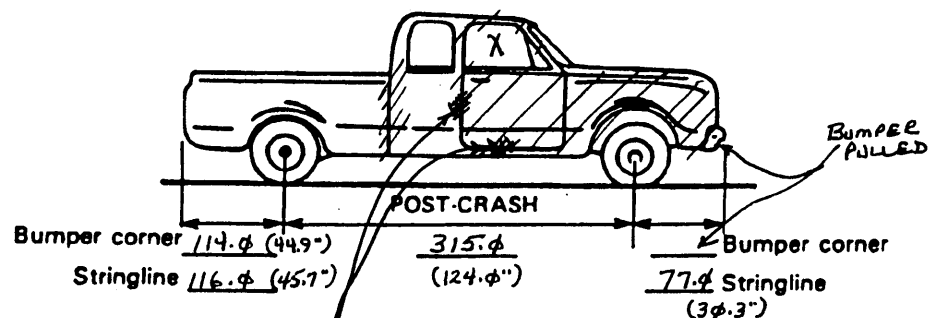
The CDC for Vehicle 2 in impact two was 09LBLE1 using a PDOF of 255 degrees. The combined direct and induced damage width was 43 cm (17 in), and the maximum crush depth was approximately 4 cm (2 in) at the left rear bumper corner. A more thorough reconstruction of this secondary impact could not be completed due to the inability to locate Vehicle 3 for inspection and the lack of cooperation from the owner of Vehicle 3.

END SHET
LEFT
> 10 cm
(4.0")

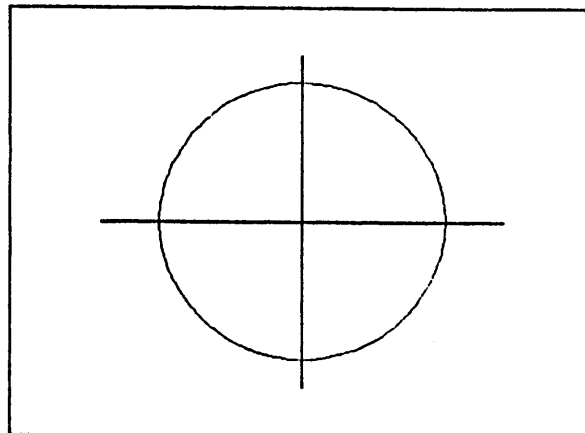
NOTE DAMAGE AND CONTACT MARKS ON AIRBAG DIAGRAMS
BELOW:

The airbag was not damaged during the crash sequence and did not yield evidence of occupant contact. The bag measured approximately 71 cm (28 in) in diameter in its deflated, post crash state. The airbag was vented by two vent ports on the back side of the bag (away from
